OHIO RIVER BASIN
CRABTREE CREEK
WESTMORELAND COUNTY

GREENWALT DAM

PHASE I INSPECTION REPORT
NATIONAL DAM INSPECTION PROGRAM

Best Available Copy JULY 1980

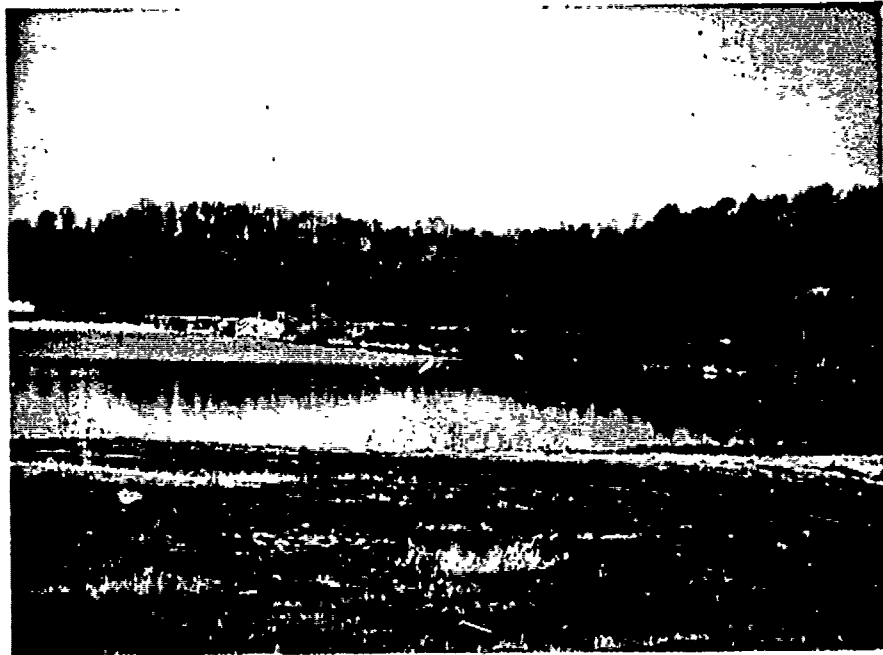
An erosional gully was noted on the upstream slope just left of the principal spillway left training wall. The erosion appeared to be the result of surface runoff from the embankment crest.

PHOTO 1. UPSTREAM SLOPE

(5) Replace lost riprap along the upstream slope of the embankment.

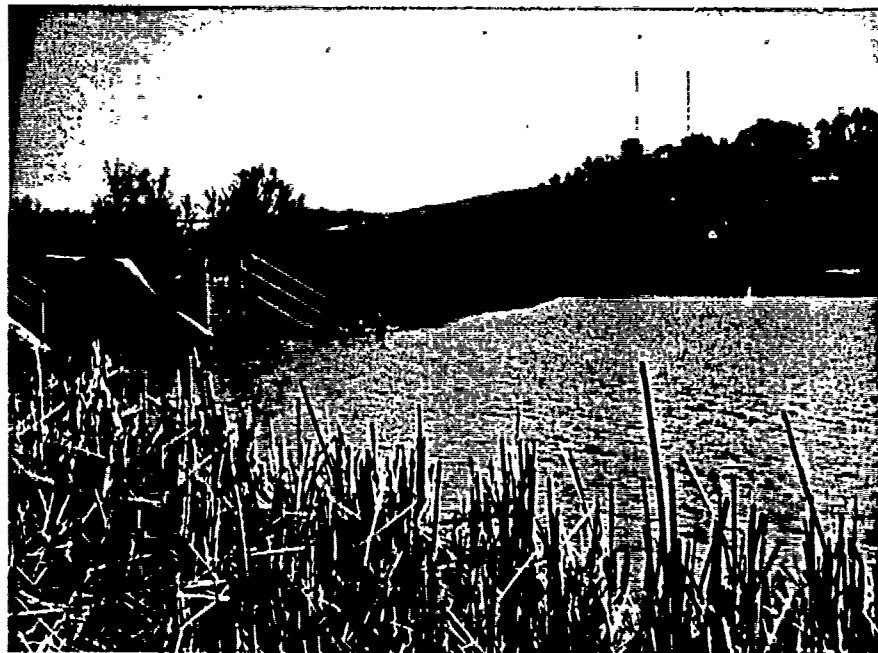
(1) Observed erosion of the upstream slope and deterioration of the upstream slope riprap protection.

PHOTO 2. UPSTREAM SLOPE

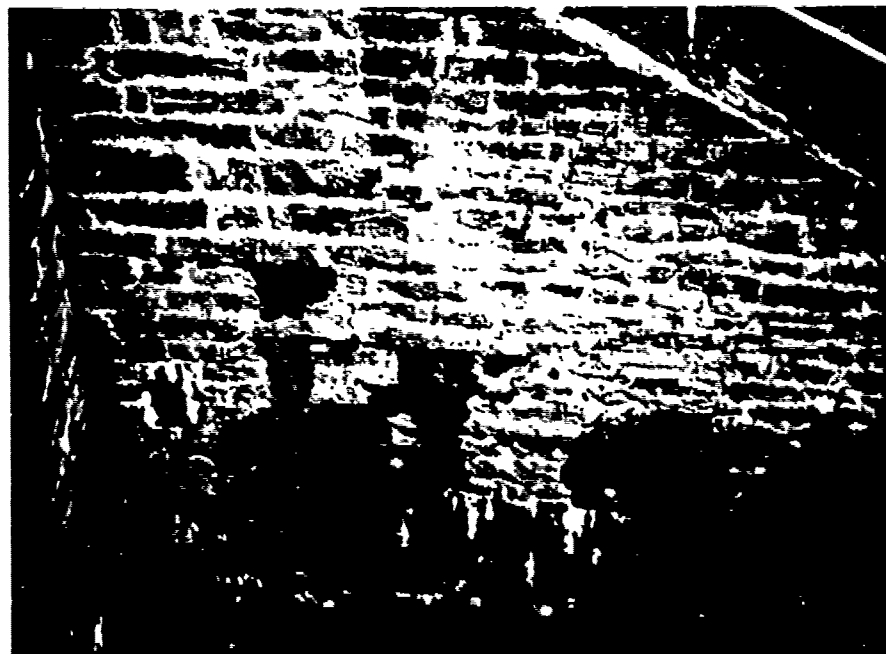
The left training wall did not contain any major cracking although numerous wet spots and small seeps were observed.

Leaks and seepage through the left training wall are also considered to be a deficiency.

PHOTO 4. LEFT SPILLWAY WALL

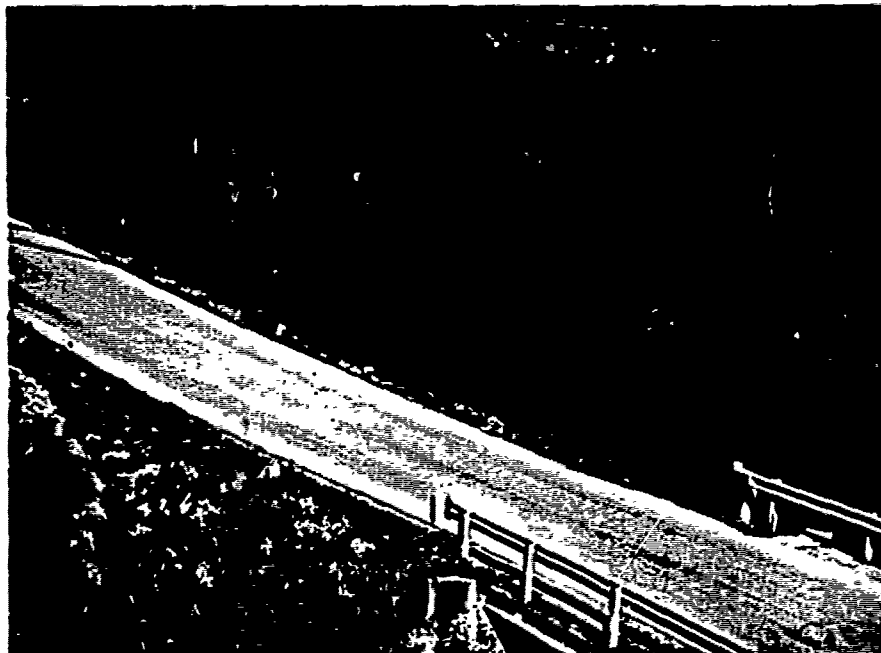
PHOTO 9. DOWNSTREAM CONDITIONS

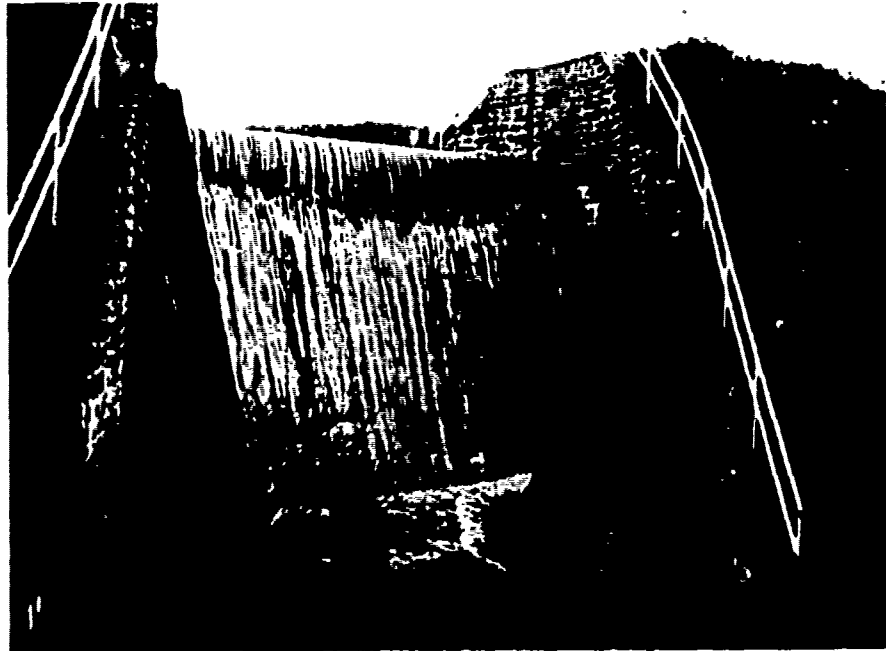
PHOTO 11. PRINCIPAL SPILLWAY
